**MINERALS MANAGEMENT SERVICE**

**HURRICANE ANDREW  
PLATFORM INSPECTION AND ANALYSIS**

**FINAL REPORT**

**PMB ENGINEERING INC.  
SAN FRANCISCO, CALIFORNIA**

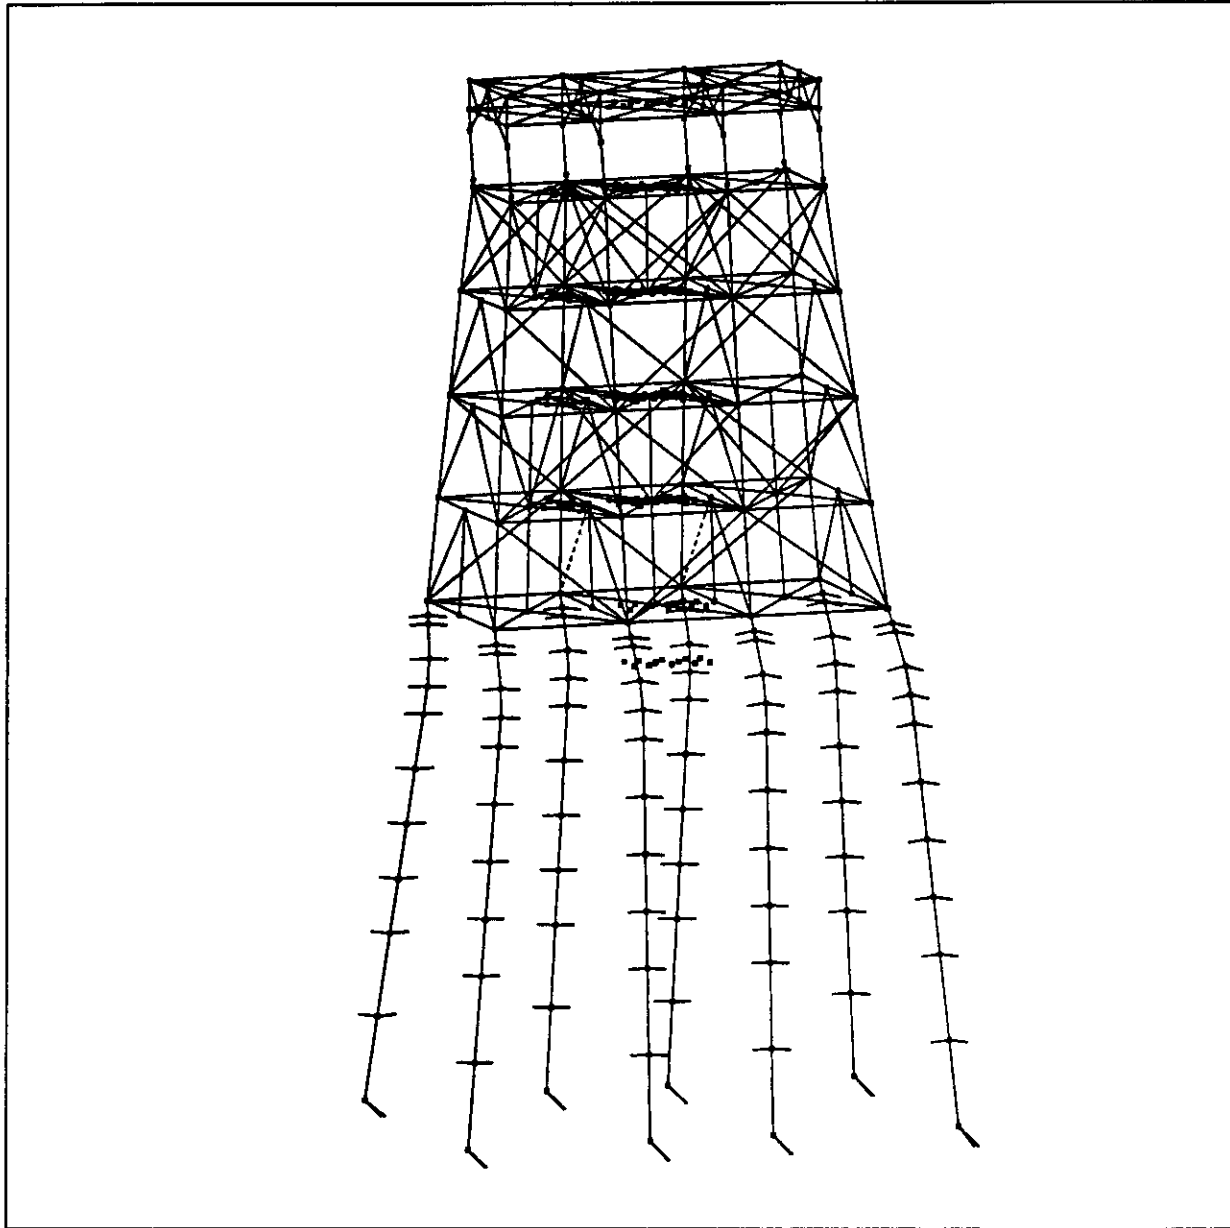
**Figure 5-6 Increased Foundation: Load Step at First Yield**

The capacity of the model with soils improved 100% is 1.00 times the Andrew environmental load or about 53% greater than the basic model's capacity. The displaced shape at first yield (bottom K braces) is shown in Figure 5-6. The displaced shapes for an intermediate step and the last load step are shown in Figures 5-7 and 5-8, respectively. The platform failure mechanism is still in the piles. All of the compression K-bracing in the top and bottom levels fail, as do the interior compression K-braces in the middle level.

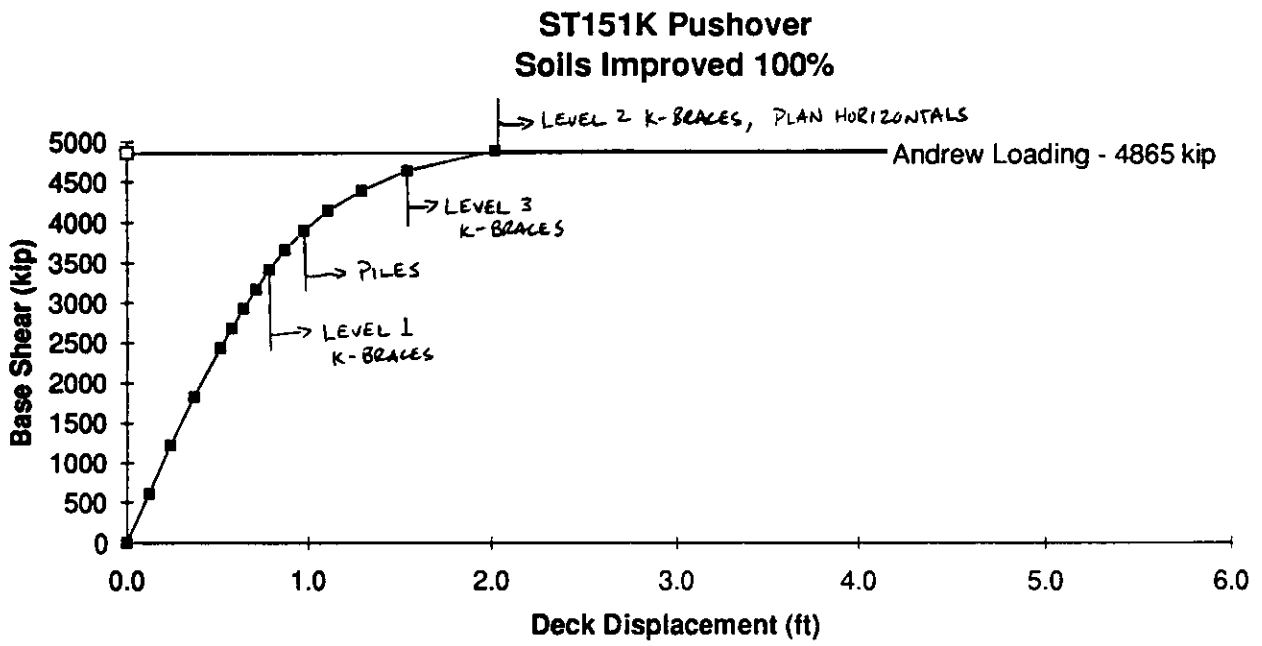
**Figure 5-9 Increased Foundation Results**

The pushover load plot is shown in Figure 5-9, with major events indicated. The general behavior is that of a gradually, smoothly decreasing stiffness, with no abrupt changes in behavior until the piles become completely plastic. All of the compression K-braces in the bottom and top levels fail, as do the two interior K-braces in the middle level. The K-braces start to fail at 0.70 times the Andrew load and the piles start to fail at 0.80 times the total environmental load. Note that the increased soil strength resulted in a larger number of brace failures in the jacket prior to global failure of the piles. This is consistent with the similar ST 177 B structure where a majority of the jacket joints had failed, yet the platform was still standing after Andrew.

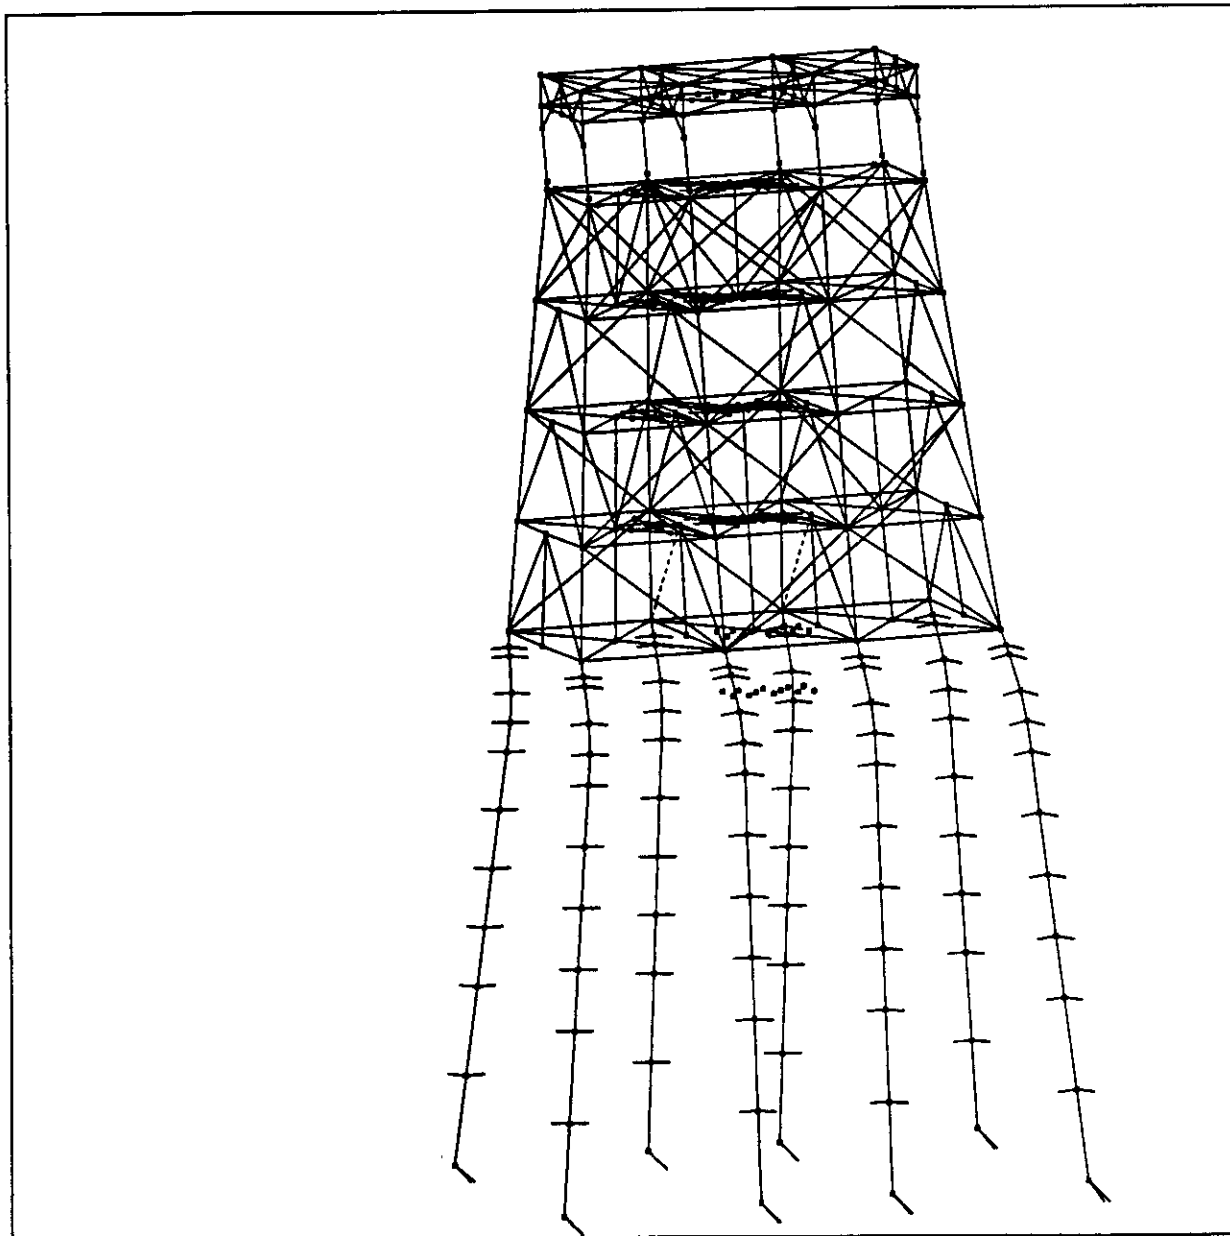
**Figure 5-10 Brittle Joints: Load Step at First Yield**

The capacity of the model with brittle K-joints and soils improved 100% is 1.01 times the Hurricane Andrew environmental pushover load or about 53% greater than the basic model's capacity. The displaced shape and first yield are shown in Figure 5-10. Yielded and failed

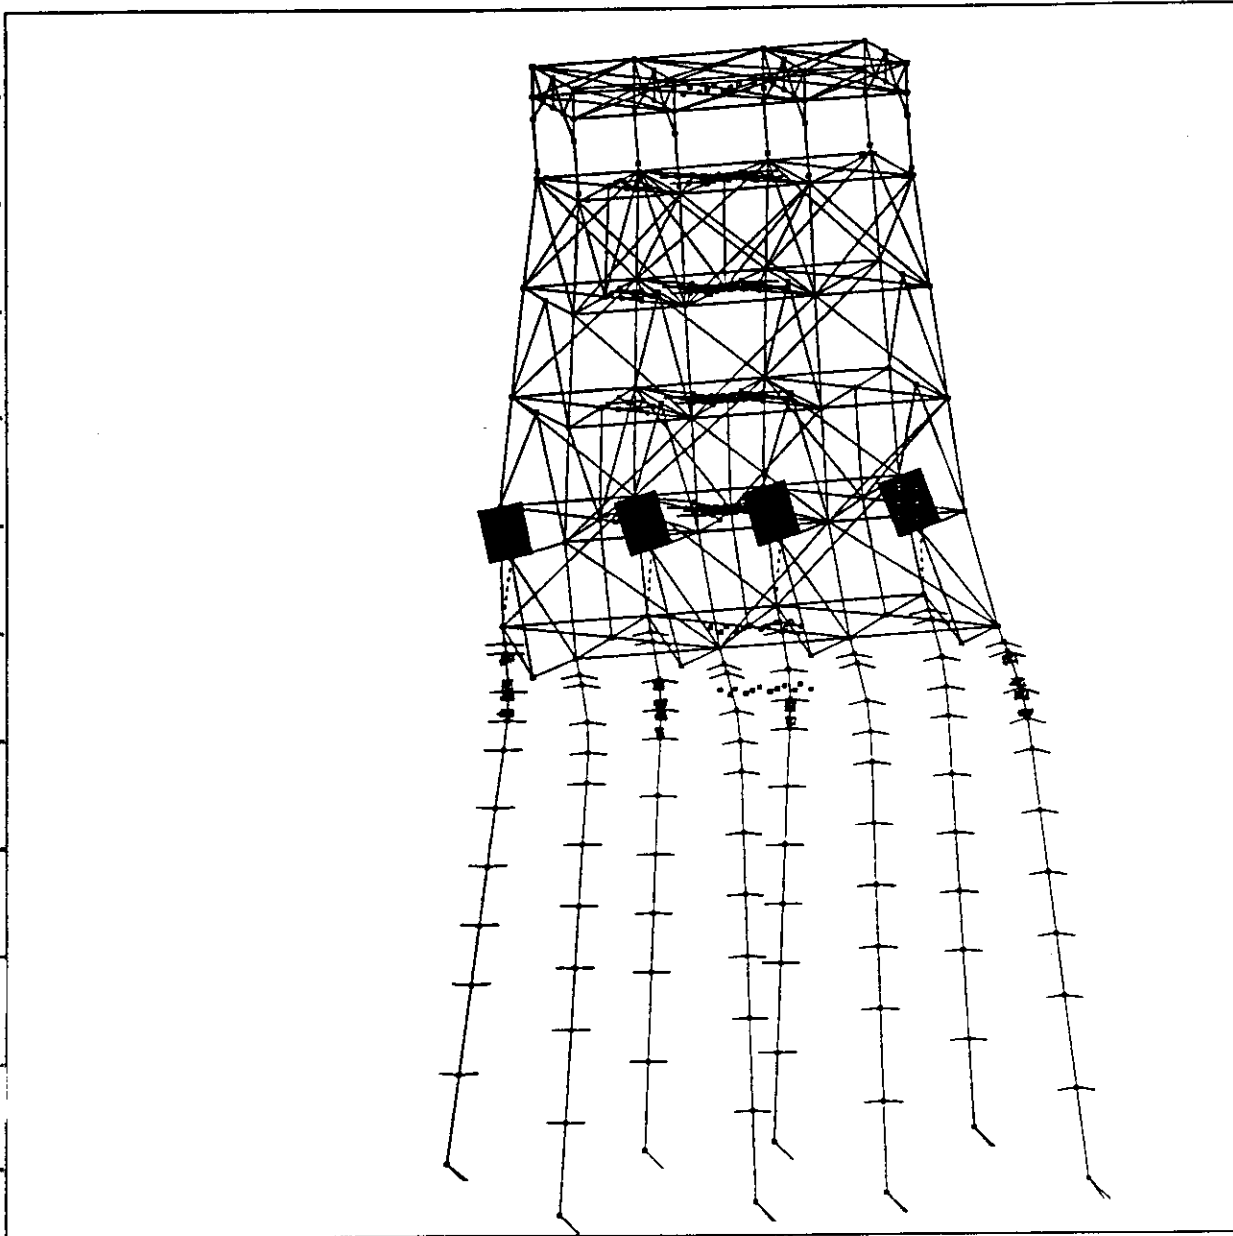
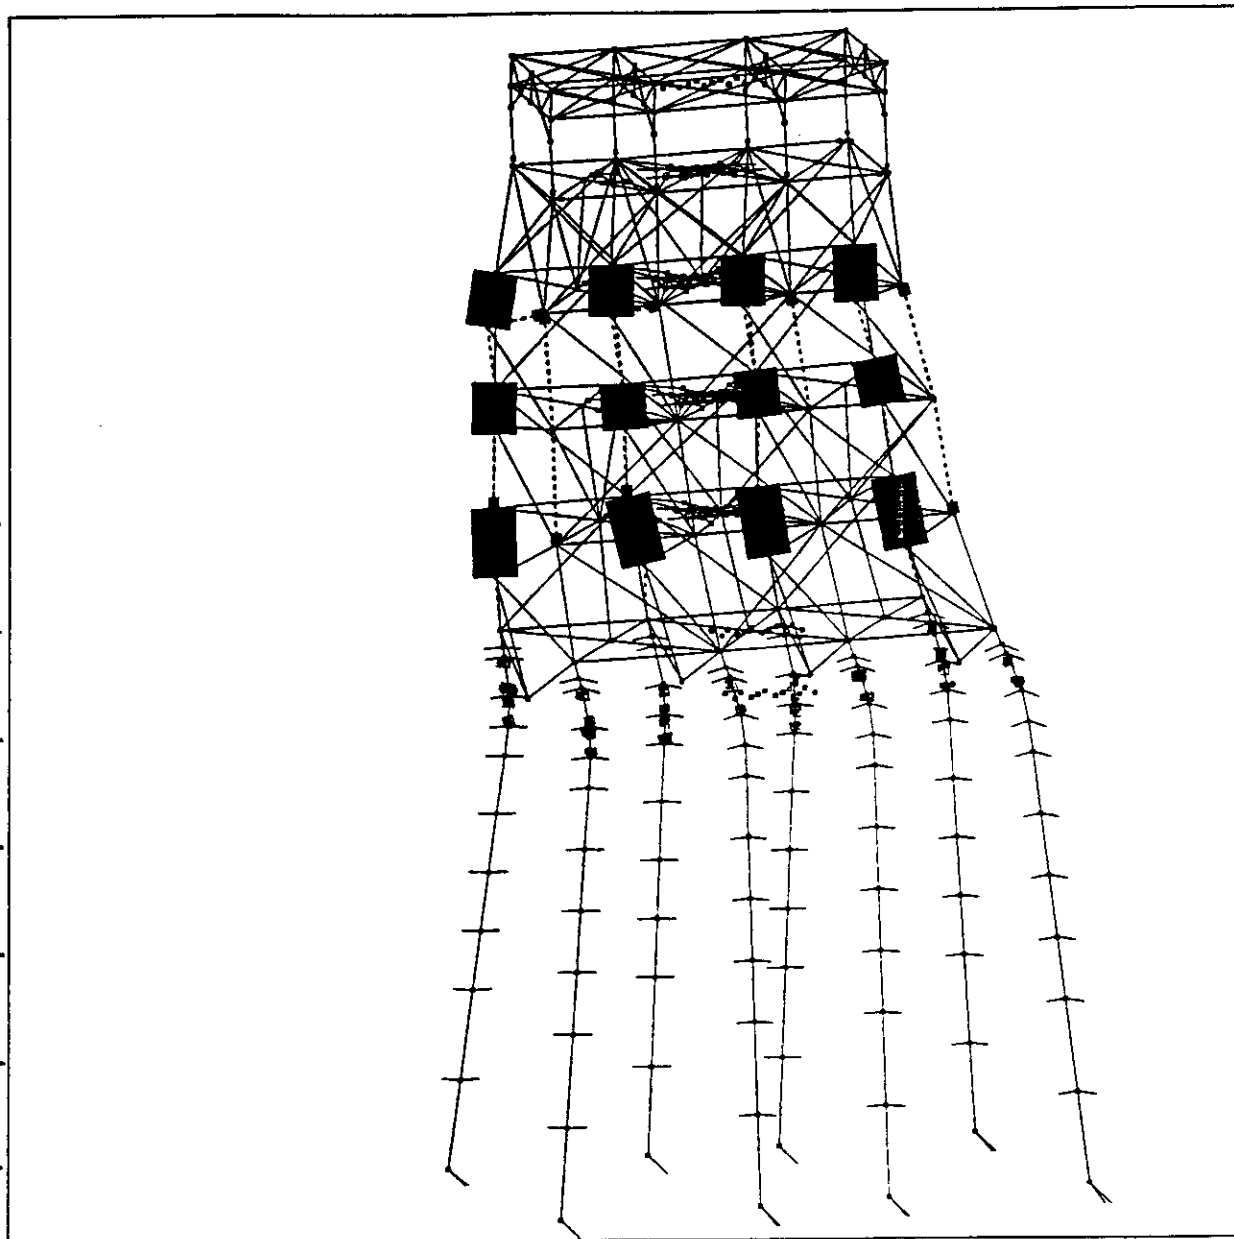
elements and their corresponding displaced shapes for an intermediate load step and the last load step are shown in Figures 5-11, 5-12. The analysis terminated due to large displacements, but it appears that the failure mechanism has moved into the jacket legs. All of the compression K-braces fail, as have the horizontals that model the K-joints. There is also some initial yielding of the legs due to the large number of brittle K brace failures, meaning the legs must carry all of the lateral load.

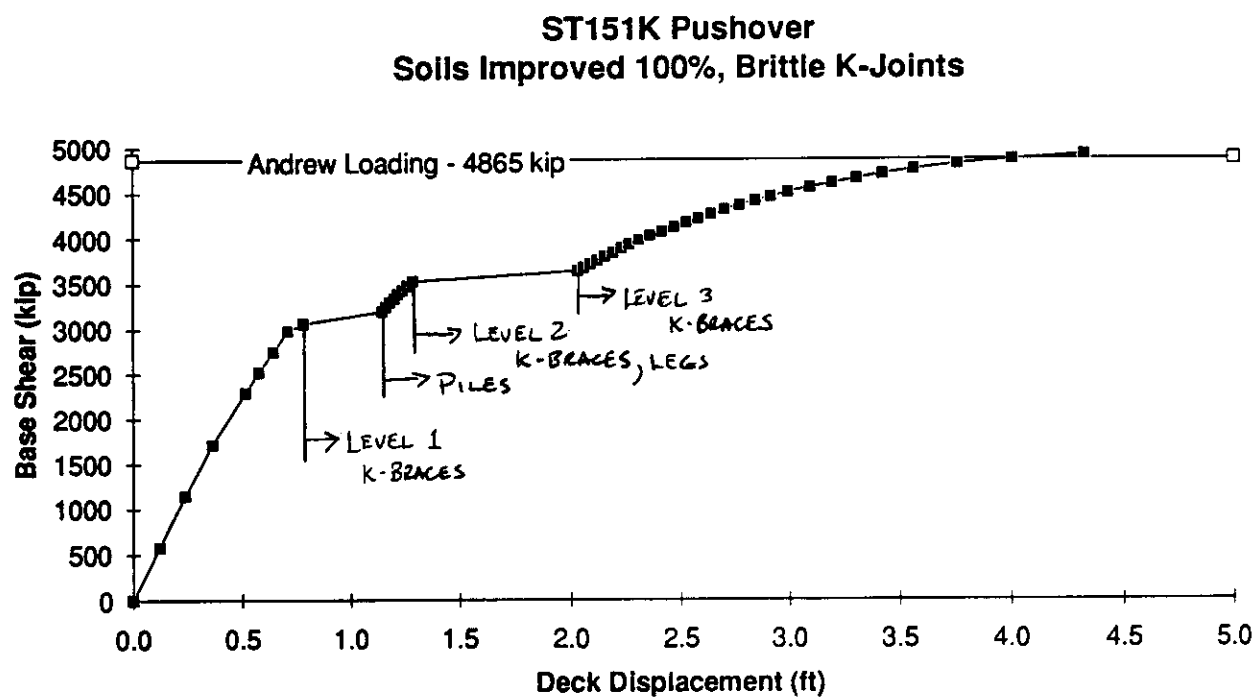
**Figure 5-13 Brittle Joints: Results**

The pushover load plot is shown in Figure 5-13, with major events indicated. The general behavior is that of a system that suddenly loses a large portion of stiffness when the bottom level K-joints fail at a load ratio of 0.63. The system loses considerable stiffness again when the middle and top level K-joints fail at a load ratio of 0.73.

This model is believed to be the best representation of the pre-Andrew platform based upon the previous ST 130 A study. The model predicts that the platform should have failed or at least suffered serious damage during Andrew. This does not compare to the actual post-Andrew platform, which was undamaged.

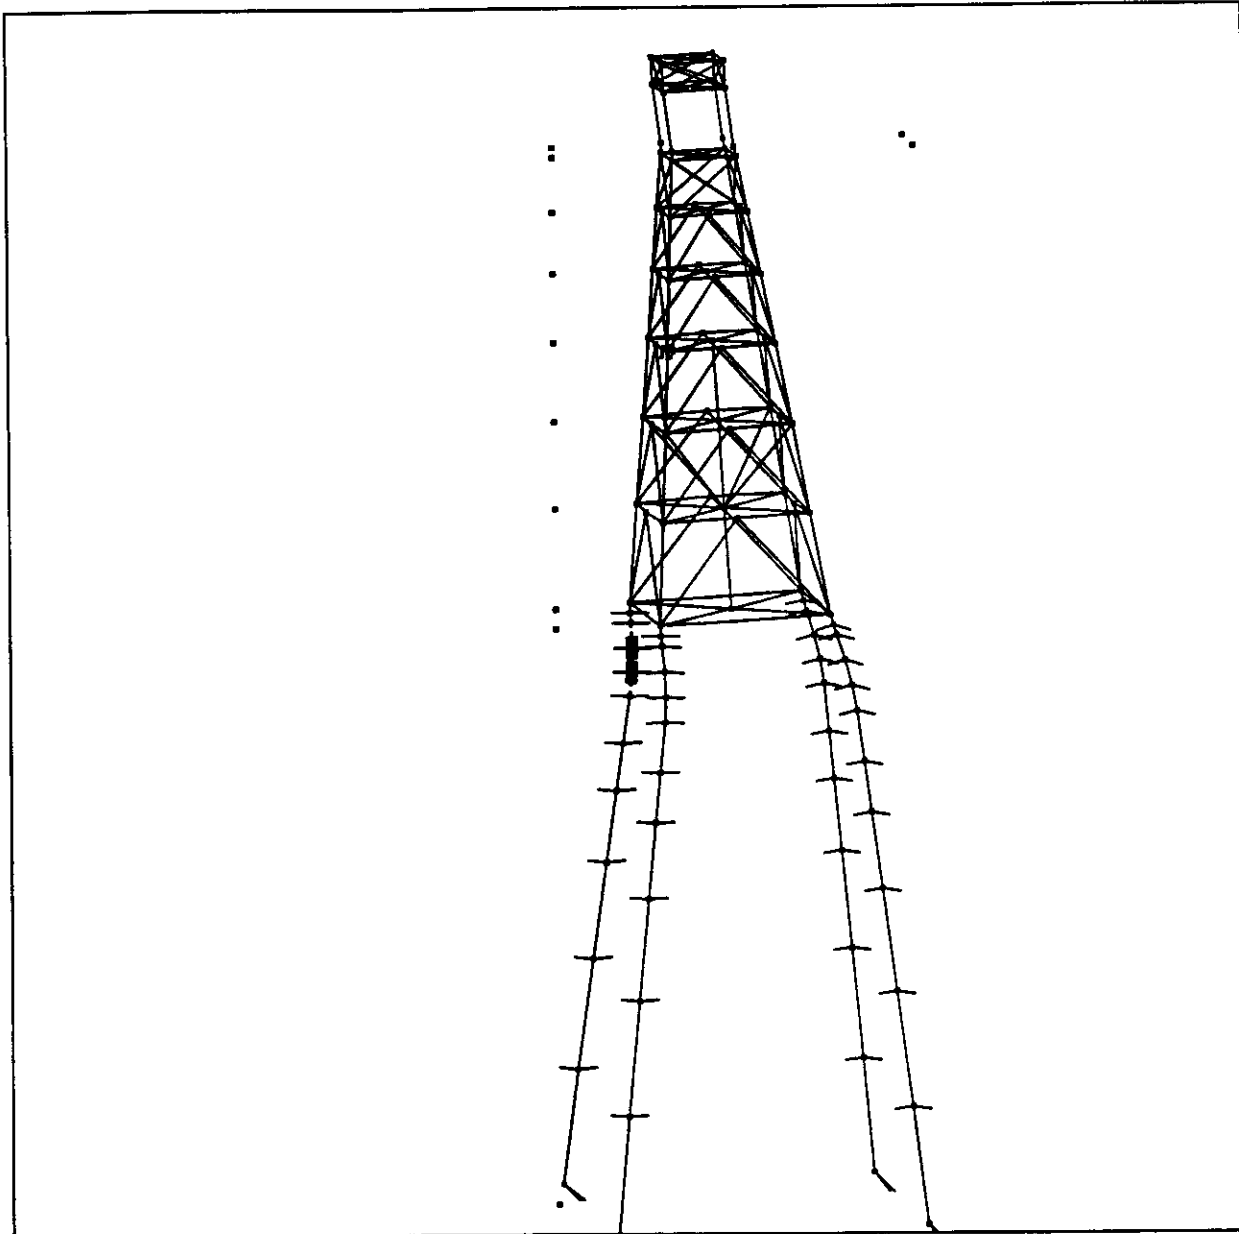
Figure 6-3 Basic Model: Load Step at First Yield

The capacity of the basic model is 1.12 times the Andrew environmental pushover load. The displaced shape and first yield are shown in Figure 6-3. Yielded and failed elements with the corresponding displaced shape for the last step is shown in Figure 6-4. The analysis terminated due to a large unbalance force in the northwest pile, but it is clear that global failure would be caused by lateral pile failure.

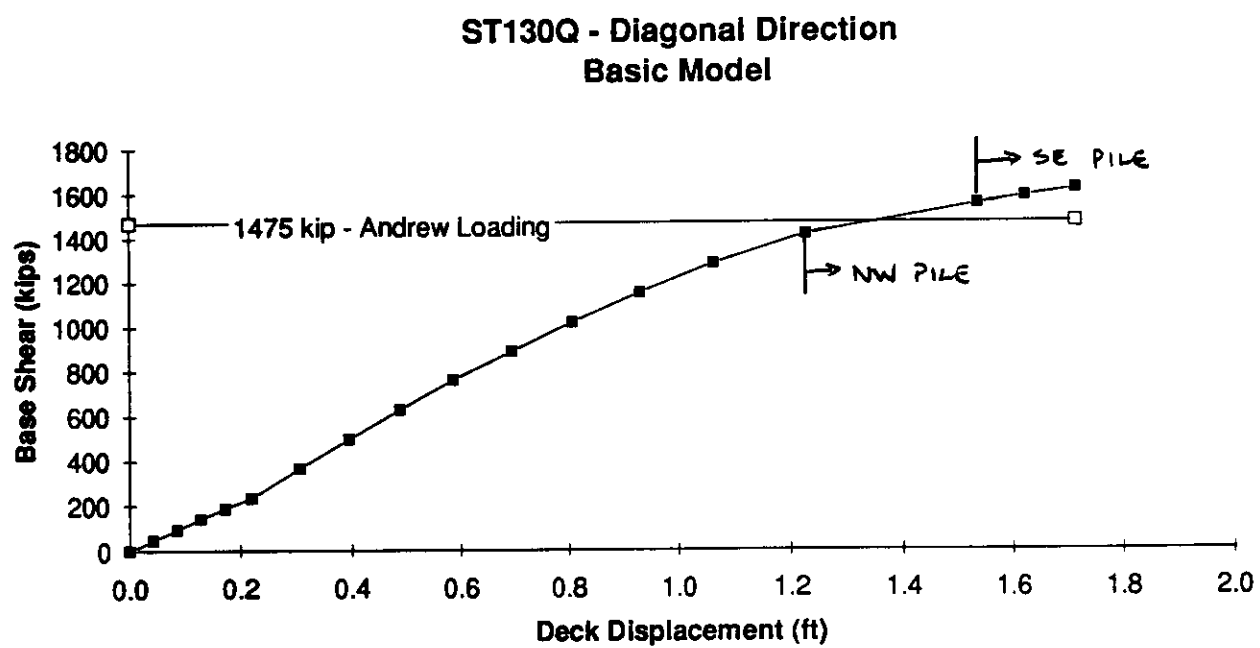
**Figure 6-5 Basic Model Results**

The pushover load plot is shown in Figure 6-5, with major events indicated. The general behavior is a gradually, fairly smooth, decreasing stiffness, with no abrupt changes in behavior until the pile failure. The first elements to fail are in the northwest corner pile. This occurs at a load level of 0.96 times the total environmental load. The southeast corner pile begins to yield at a load ratio of 1.05. None of the K-braces fail in this analysis.
